# In-Field Monitoring of the Durability of Composite Materials

20 August 2001

G. F. HAWKINS, G. L. STECKEL, J. P. NOKES,  
and J. L. BAUER  
Space Materials Laboratory  
Laboratory Operations

CALIFORNIA DEPARTMENT OF TRANSPORTATION  
Sacramento, CA 94273-0001

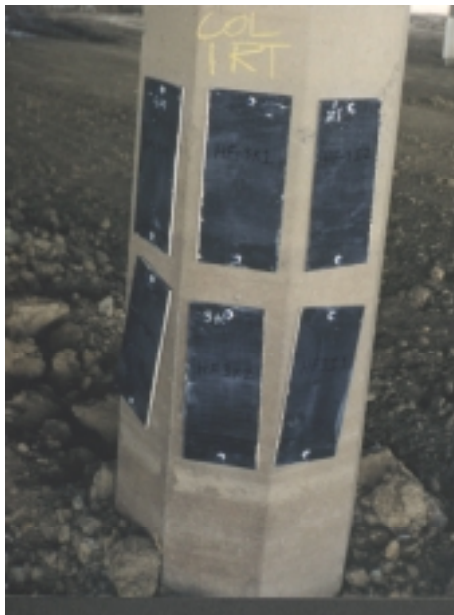
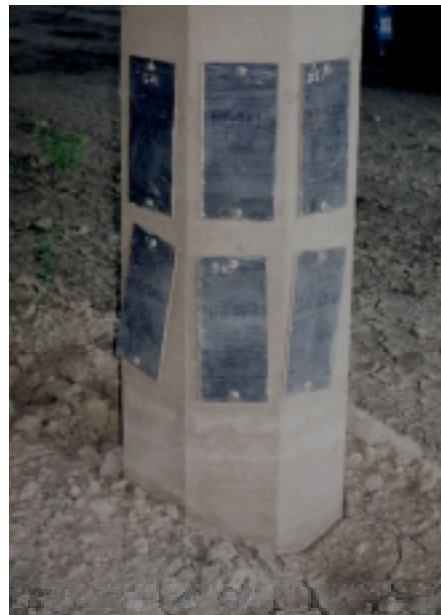
Figure 2.3. Photographs of Fyfe Co. SCH 41/Tyfo S carbon/epoxy panels taken at beginning (left) and after 1-yr field exposure.

one-year exposure. Sample identification numbers were obscured or removed from several panels, particularly the E-glass/polyester panels fabricated by Myers Technologies, Inc. However, there was no evidence of physical damage to any of the composite panels following the first year of exposure.

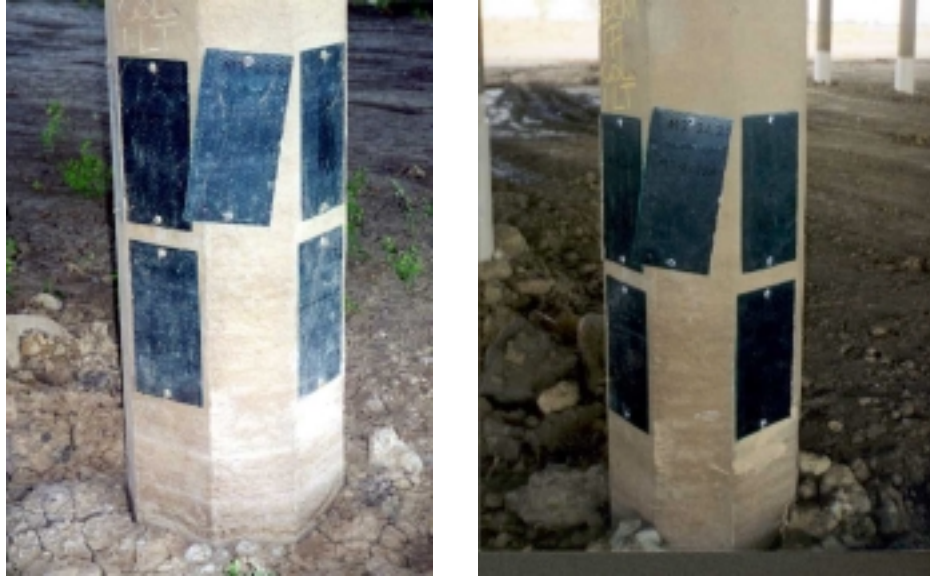
Figure 2.4. Photographs of Mitsubishi Chemical Corp. Replark 30/L700S-LS carbon/epoxy panels taken at beginning (left) and after 1-yr field exposure. Panel No. M2-2L1A was mounted on northwest side of the column and is not shown in photographs.

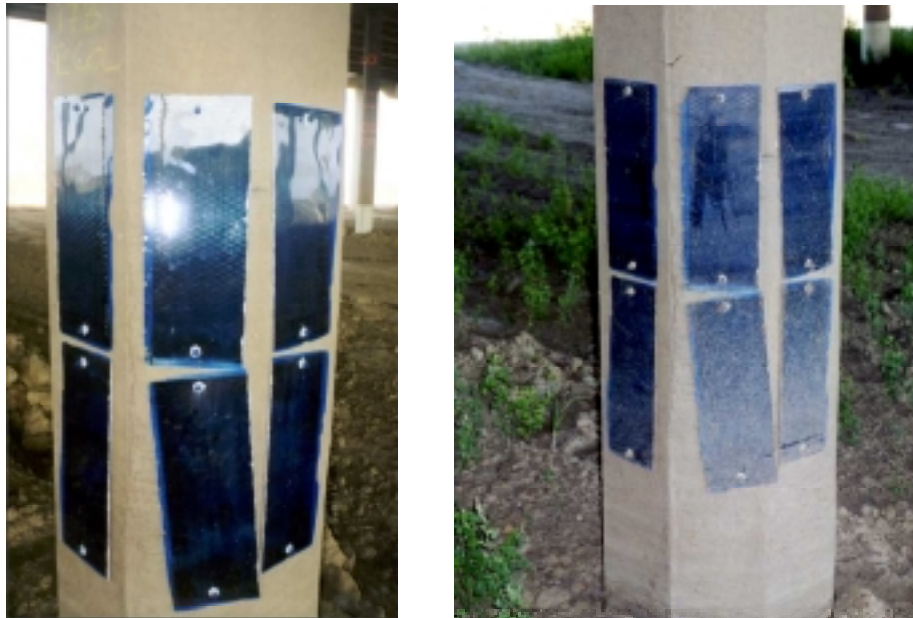
Figure 2.5. Photographs of Master Builders, Inc. CF130/MBrace™ Epoxy Carbon/Epoxy panels taken at beginning (left) and after 1-yr field exposure.

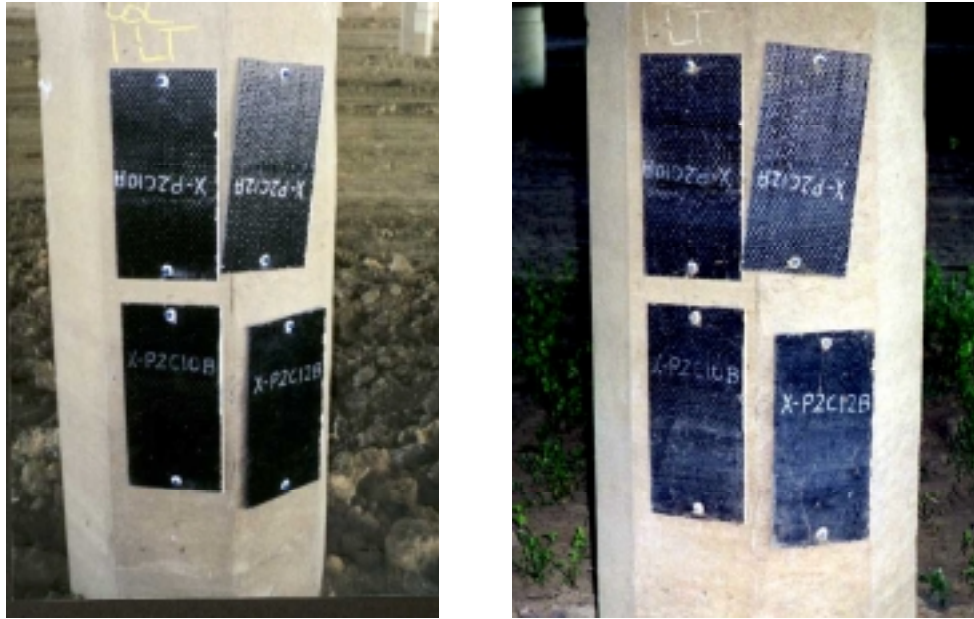
Figure 2.6. Photographs of Xxsys Technologies, Inc. Akzo/Epon 828 Carbon/Epoxy panels taken at beginning (left) and after 1-yr field exposure.

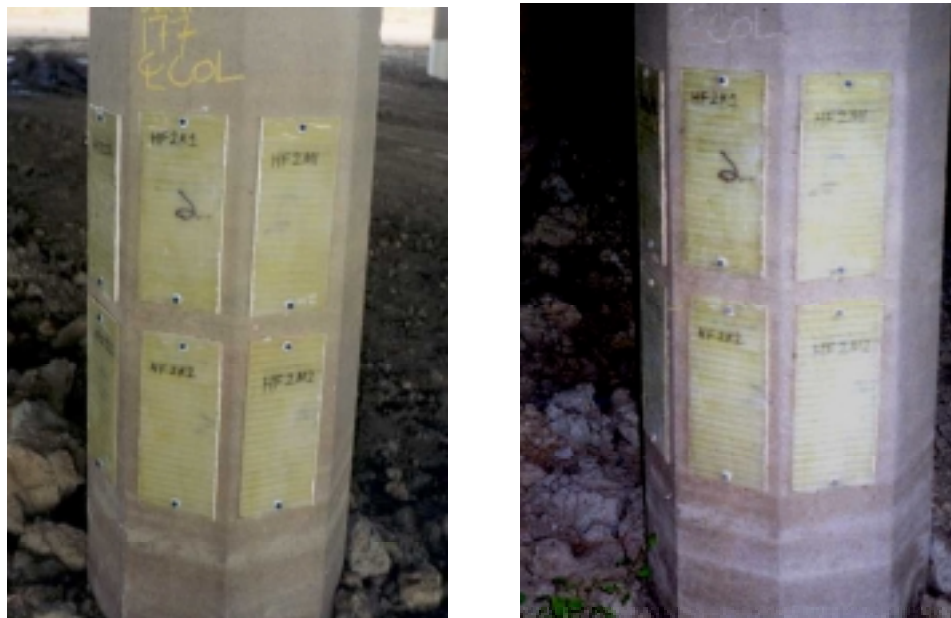
Figure 2.7. Photographs of Fyfe Co. SEH 51/Tyfo S E-glass/Epoxy panels taken at beginning (left) and after 1-yr field exposure.

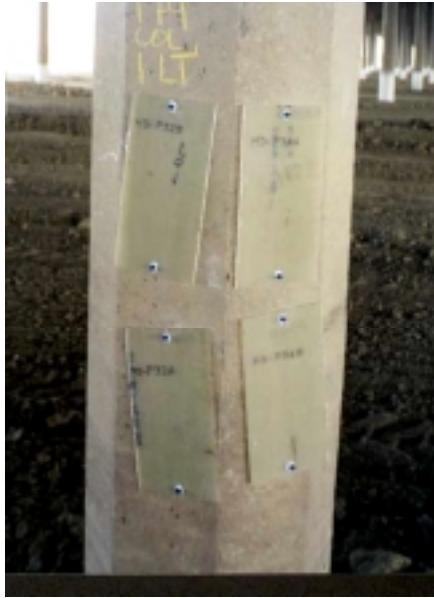
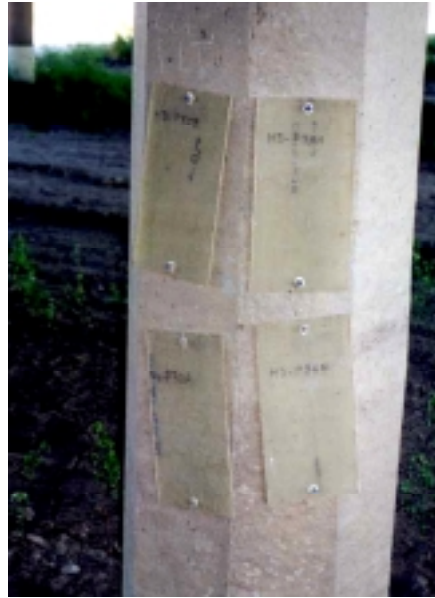
Figure 2.8. Photographs of Hardcore Composites E-glass/Vinyl Ester panels taken at beginning (left) and after 1-yr field exposure.

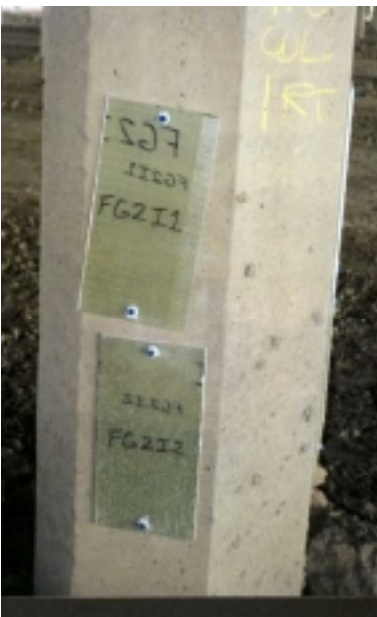
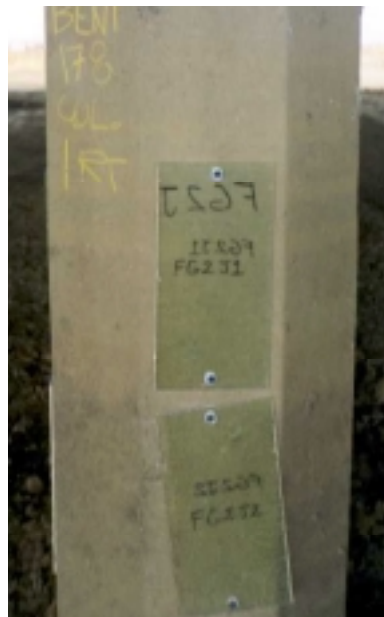
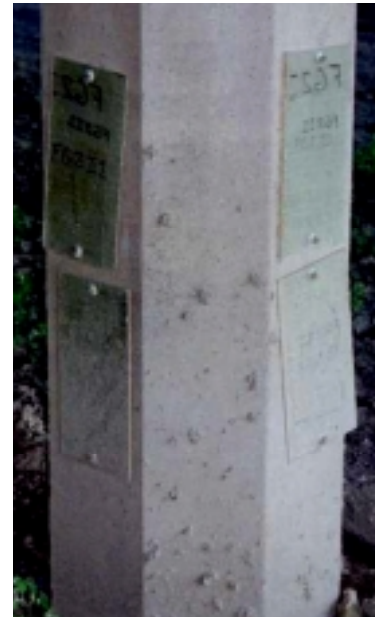
Figure 2.9. Photographs of Fyfe Co. SEH 51S/Tyfo® S Fiberglass/Epoxy panels taken at beginning (left and middle) and after 1-yr field exposure.

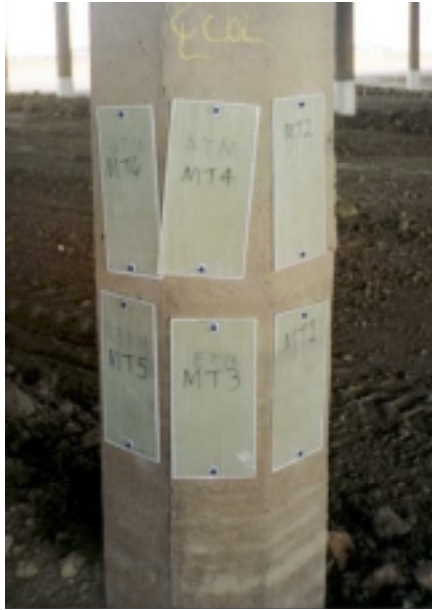
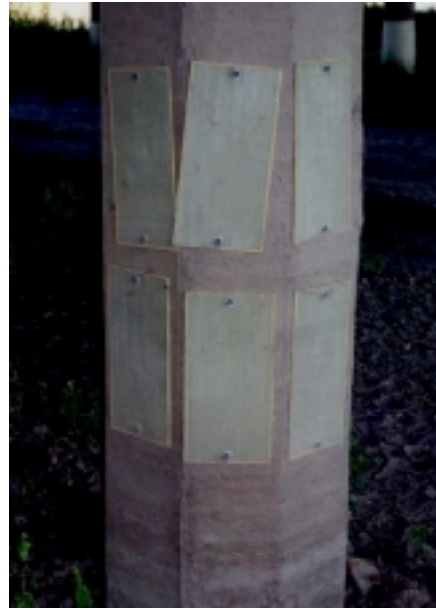
Figure 2.10. Photographs of Myers Technologies, Inc. E-glass/Polyester panels taken at beginning (left) and after 1-yr field exposure.

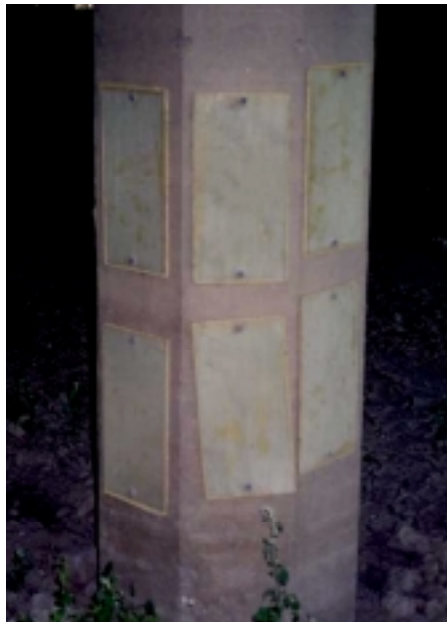
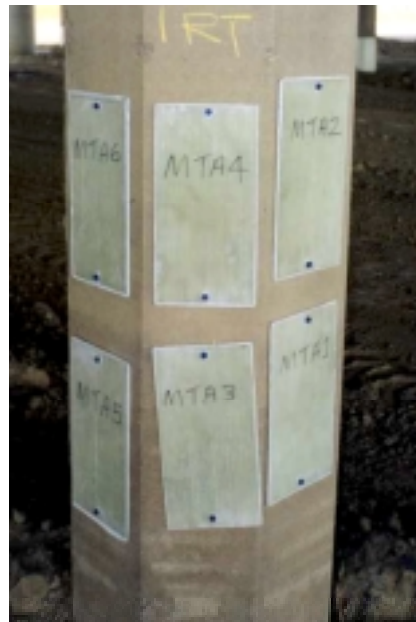
Figure 2.11 Photographs of Myers Technologies, Inc. E-glass/Polyester/MOR-AD-695-28 Adhesive bonded panels taken at beginning (left) and after 1-yr field exposure.

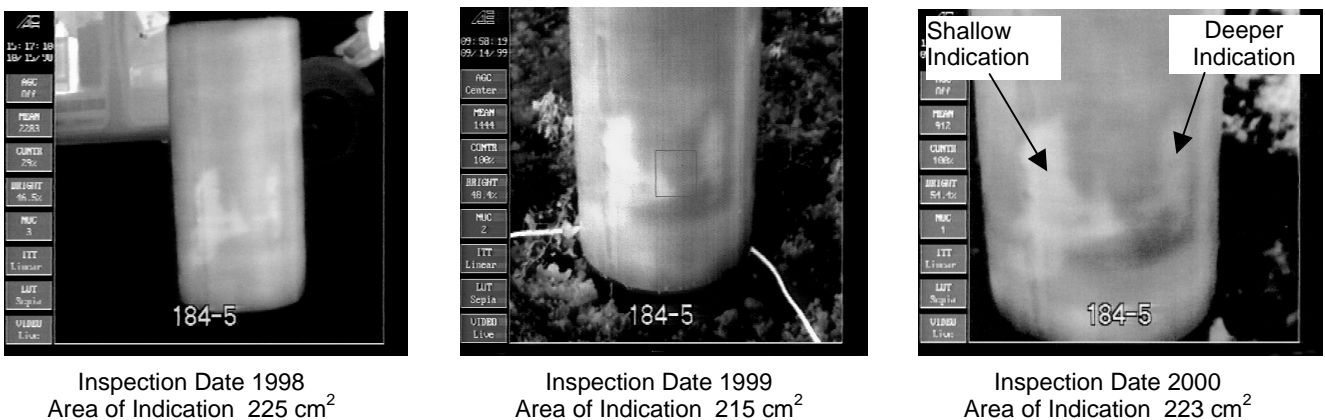
Variations in the measured indication areas can be related to a number of factors, including year-to-year changes in the inspection procedure, and uncertainty in the image intensity can have some impact on the boundaries of the indications. Based on the experience gathered from these inspections,

Figure 4.10. IR images of a specific indication acquired over a period of 3 years. The areas of interest appear as light regions on the composite sleeve..

an increase in the area of more than 25% in the measured area would be required to demonstrate growth in a particular indication. Figure 4.11 is a representation of the measured areas of the unbond indications. None of the eight columns showed a significant increase in the indication area. This suggests that the time scale required for environmental water to infiltrate the columns and increase the unbonded area is longer than 3 years.

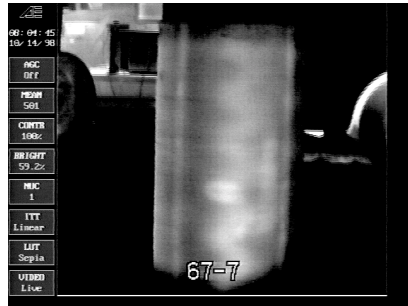
Inspection Date 1998  
Total Area of Indication 192 cm<sup>2</sup>

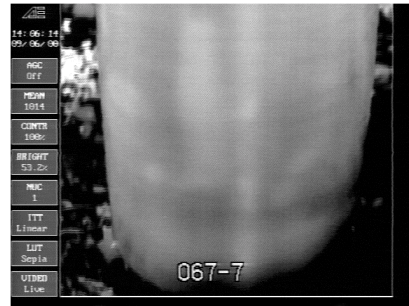
Inspection Date 2000  
Total Area of Indication 193 cm<sup>2</sup>

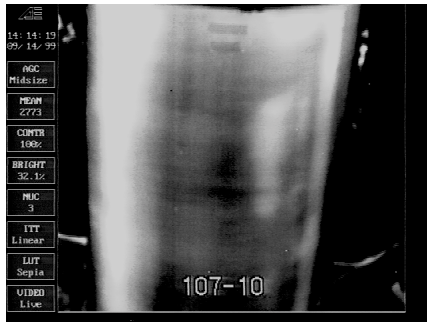
Inspection Date 1999  
Area of Indication 73 cm<sup>2</sup>

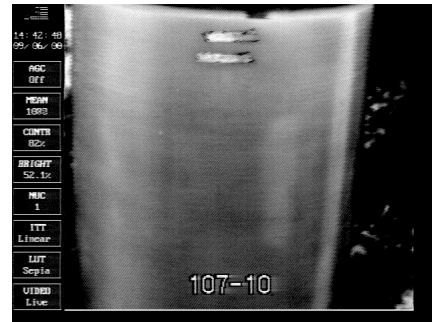
Inspection Date 2000  
Area of Indication 73 cm<sup>2</sup>

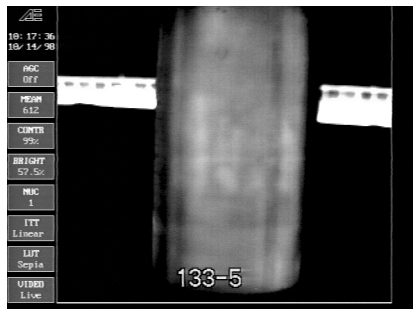
Inspection Data 1998  
Area of Indications 185 cm<sup>2</sup>

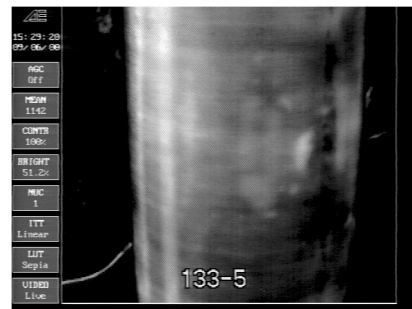
Inspection Data 2000  
Area of Indications 160 cm<sup>2</sup>

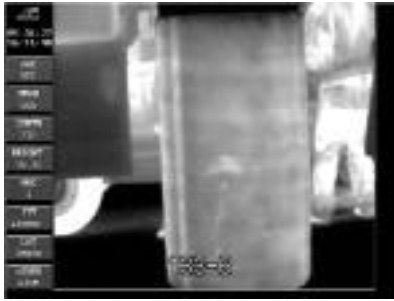
Inspection Data 1998  
Area of Indications 40 cm<sup>2</sup>

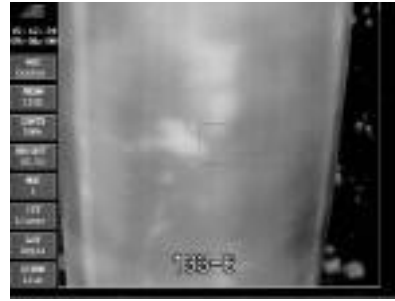
Inspection Data 2000  
Area of Indications 36 cm<sup>2</sup>

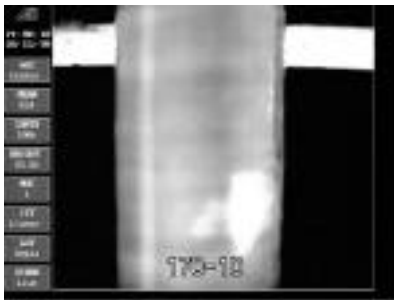
Inspection Data 1998  
Area of Indications 167 cm<sup>2</sup>

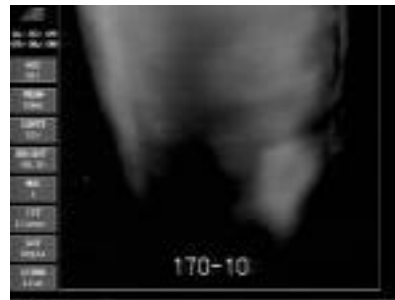
Inspection Data 2000  
Area of Indications 174 cm<sup>2</sup>

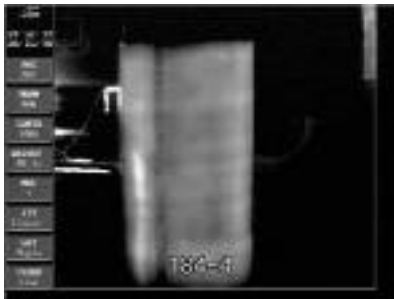
Inspection Data 1998  
Area of Indications 131 cm<sup>2</sup>

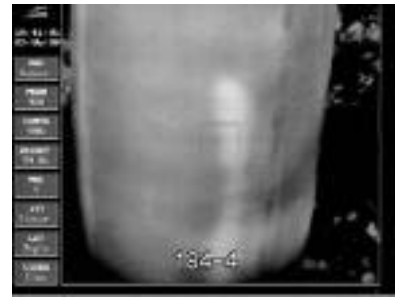
Inspection Data 2000  
Area of Indications 105 cm<sup>2</sup>

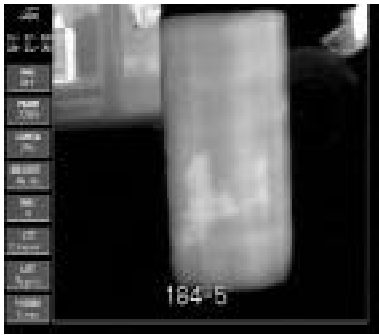
Inspection Date 1998  
Area of Indication 225 cm<sup>2</sup>

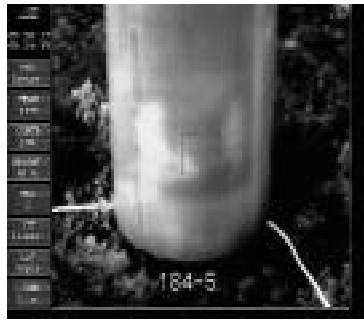
Inspection Date 1999  
Area of Indication 215 cm<sup>2</sup>

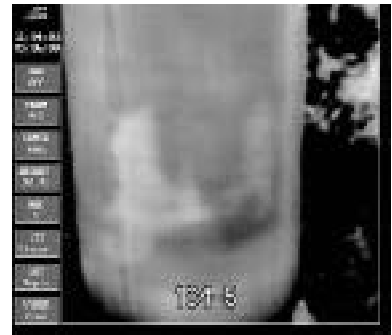
Inspection Date 2000  
Area of Indication 223 cm<sup>2</sup>

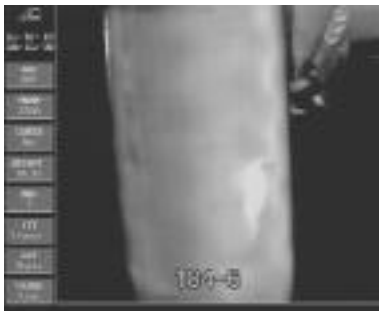
Inspection Date 1998  
Area of Indication 66 cm<sup>2</sup>

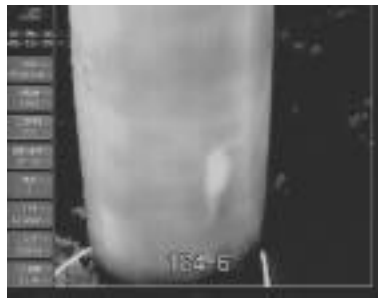
Inspection Date 1999  
Area of Indication 60 cm<sup>2</sup>

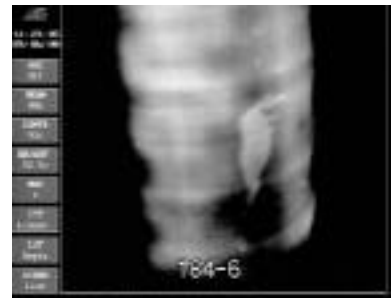
Inspection Date 2000  
Area of Indication 70 cm<sup>2</sup>
